Joint Task Force ONE Director of Ship Material

ARMOR AND METALLURGY PHOTOGRAPHIC INDEX

TESTS "A" AND "B"

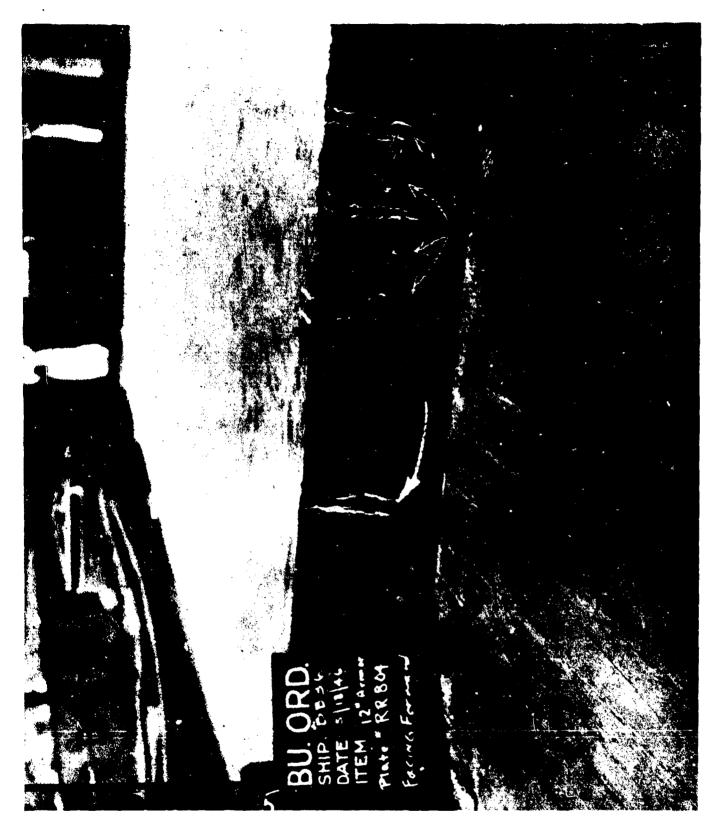
U,S.S. NEVADA - BB-36 - Before Able 12 Armor Plate No. RR804. Located portside aft. Chalks marks indicate gas cutting cooling cracks. This plate remained aboard for Test Baker. Photo. No. BAGR83-272-5

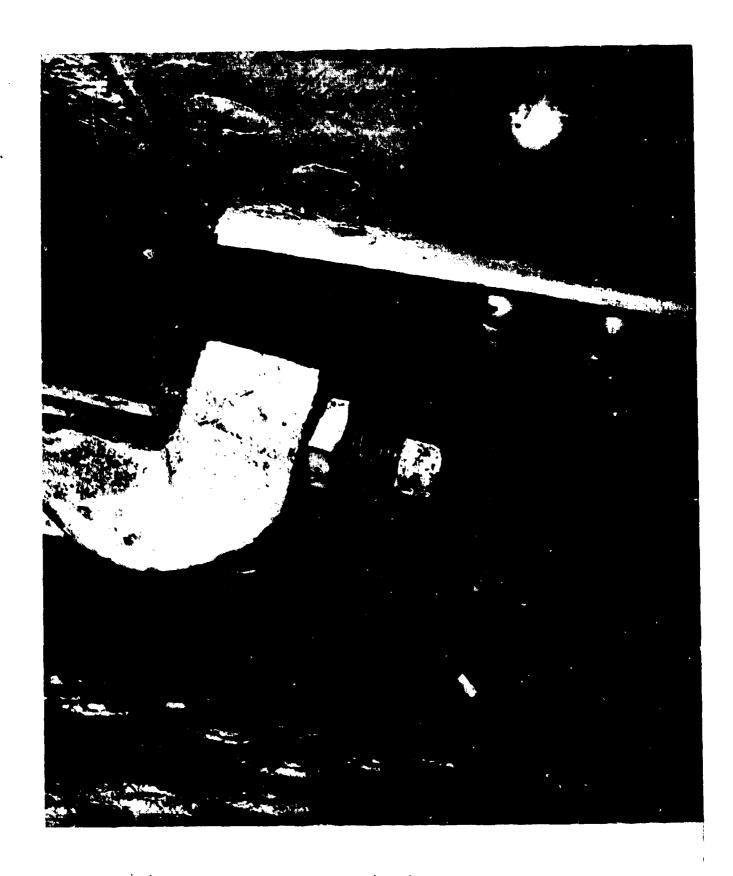
U.S.S. NEW YORK (BB34) - After Baker Turret four holding down clip. This clip has horizontal crack on inboard side for a length of 6 inches. Throws clip out of alignment due to shock. Photo. No. ABCR 234-2207-1.

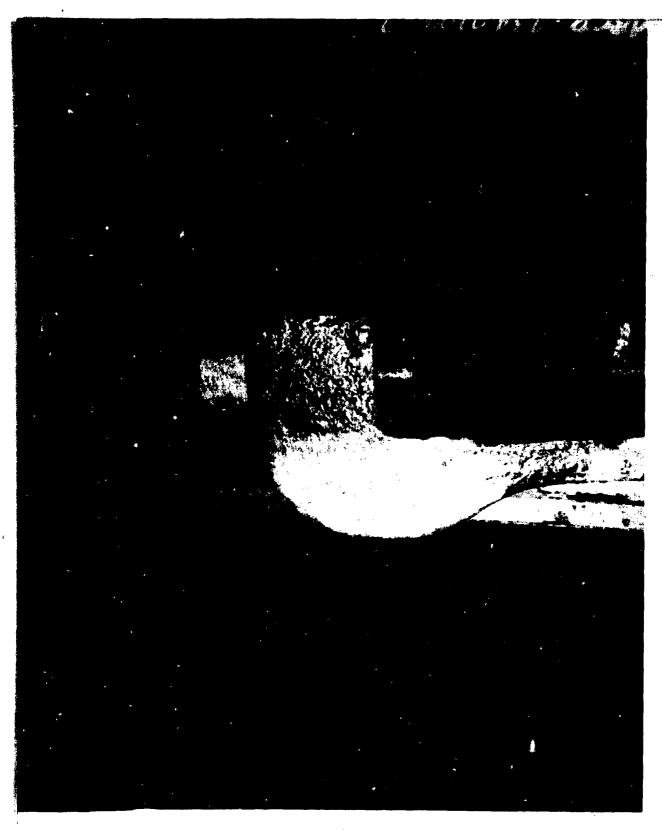
U.S.S. NEW YORK (BB-34) - After Eaker. Turnet four holding clip. Same as ABCR 234-2007-1, ABCR 234-2207-4,5,6 and 7 - U.S.S. NEW YORK, turnet four holding down clip. Showing fractured clip with section resting on positive buffer.

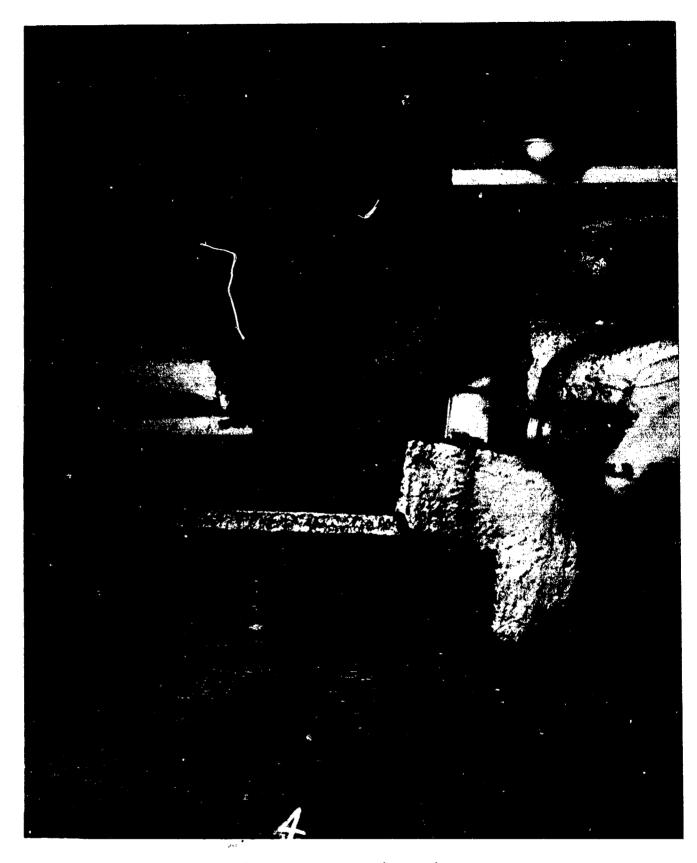
U.S.S. NEW YORK (BB-34) - After Eaker Turret four holding clip, showing fractured clip with section resting on positive buffer. Photo. No. ABCR 284-0207-4.

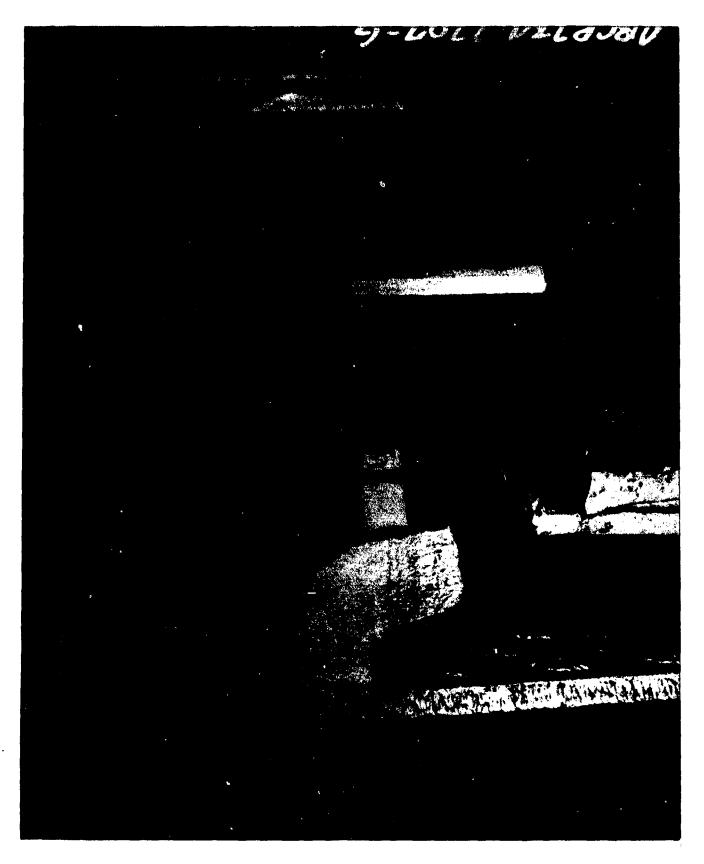
U.S.S. NEW TORK (BB-34) - After Taker.
Turret four holding clip. Shows fractured cli) with section resting on positive buffer.
Photo. No. ABCR 234-2207-6.

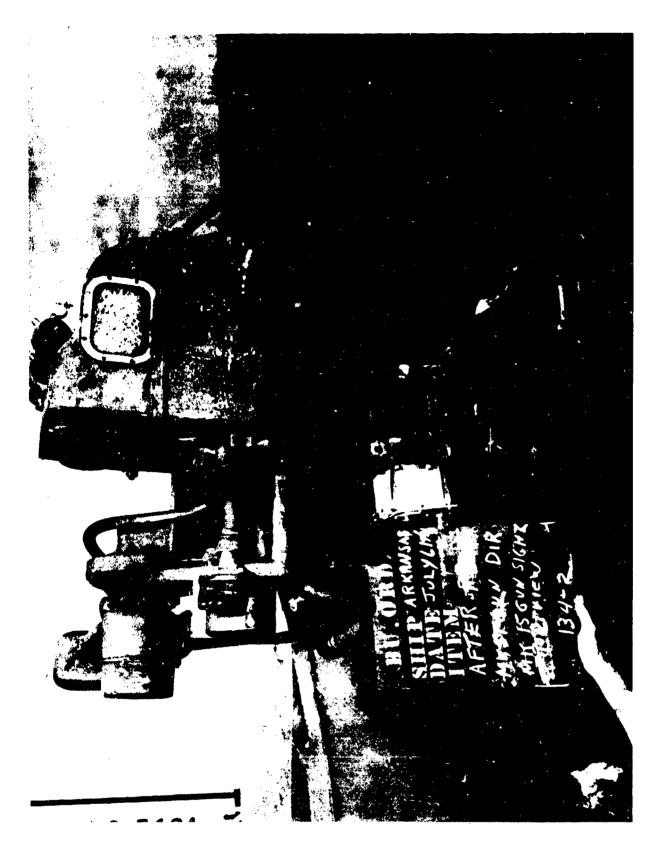
U.S.S. ARKANSAS (BB-33) - After Able Gun Director, Mk. 51, Mod. 3 (After Port Air Defense) Showing ruptured air drier container, train locking-pin broken from mounting, left elevation counterbalance weight missing, and air intake-line broken. Photo. No. AA-CR-60-134-1.

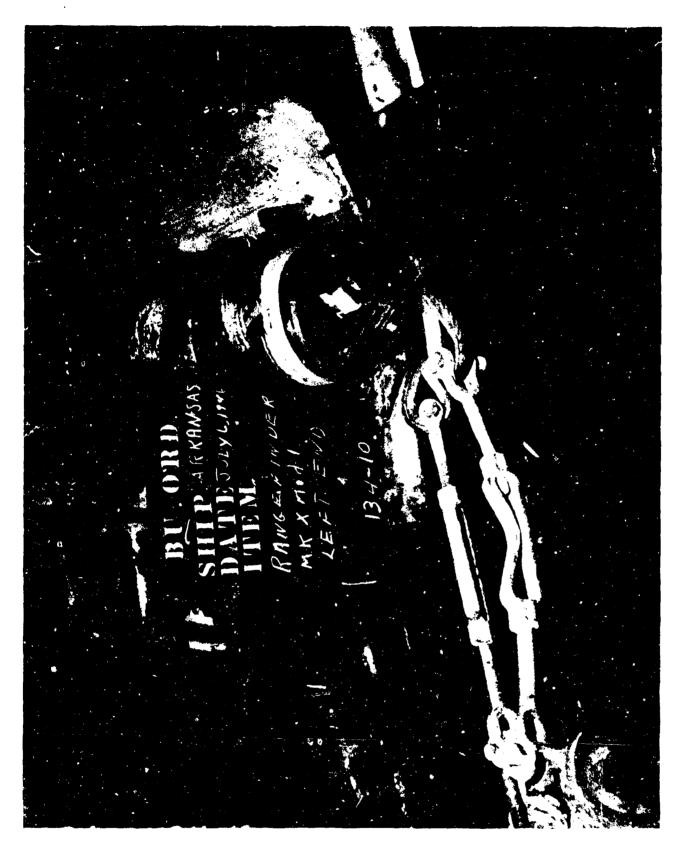
U.S.S. ARKANSAS (BB-33) - After Able Rangefinder, Mk. 10, Mod. 1 (Atep Turret #5) Showing ruptured housing, absence of end-box, and inner end-box assembly. Photo. No. AA-CR-60-134-10.

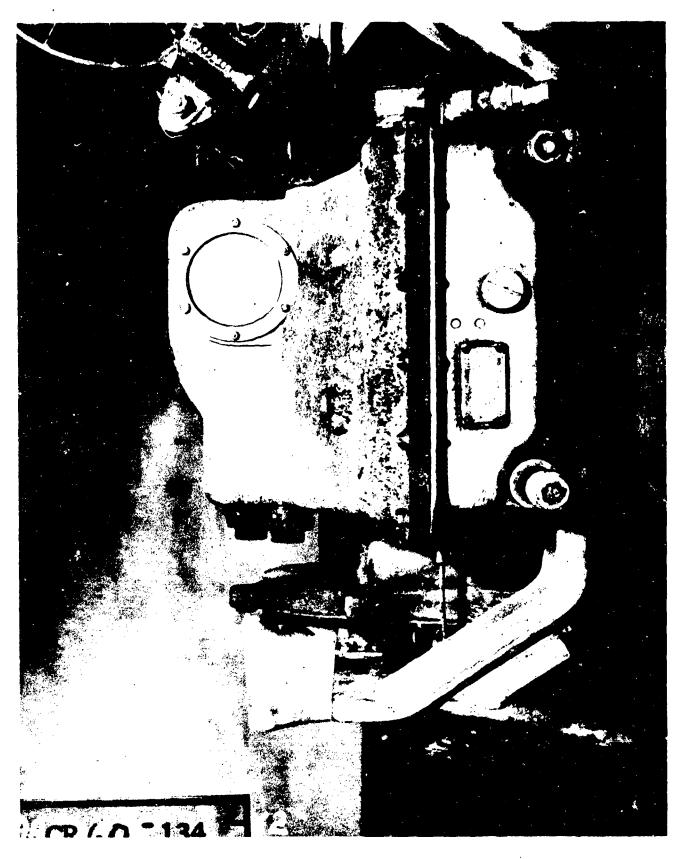
U.S.S. ARKANSAS (BB-33) - After Able Gunsight, Mk. 14, Mod. 8 (Forward starboard Gun Director, Mk. 51). Showing cracked front window and scorched case. Photo. No. AA-GR-60-134-12.

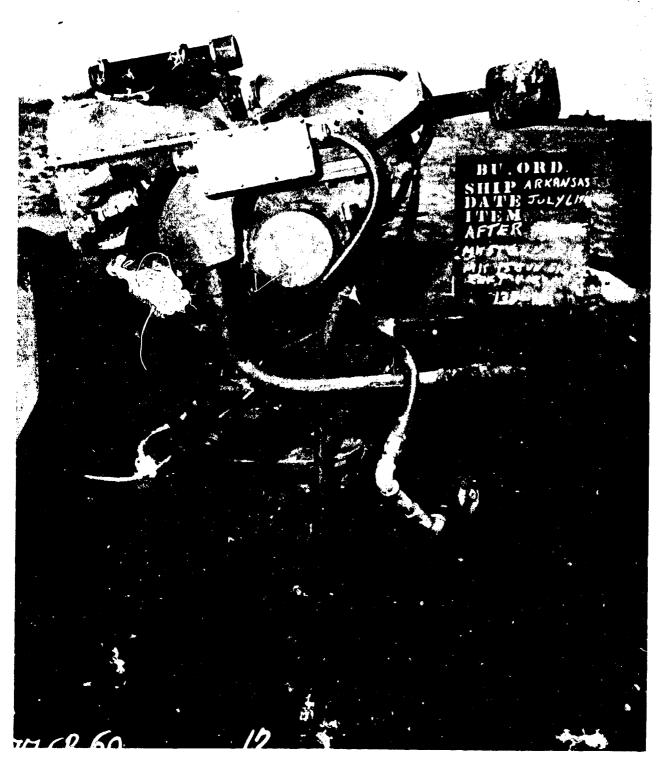
U.S.S. ARKANSAS (BB-33) - After Able Gun Director, Mk. 51, Mod. 3 (Starboard after air defense) Showing bent splinter shield and broken air drier fitting. Photo. No. AA-CR-60-138-11.

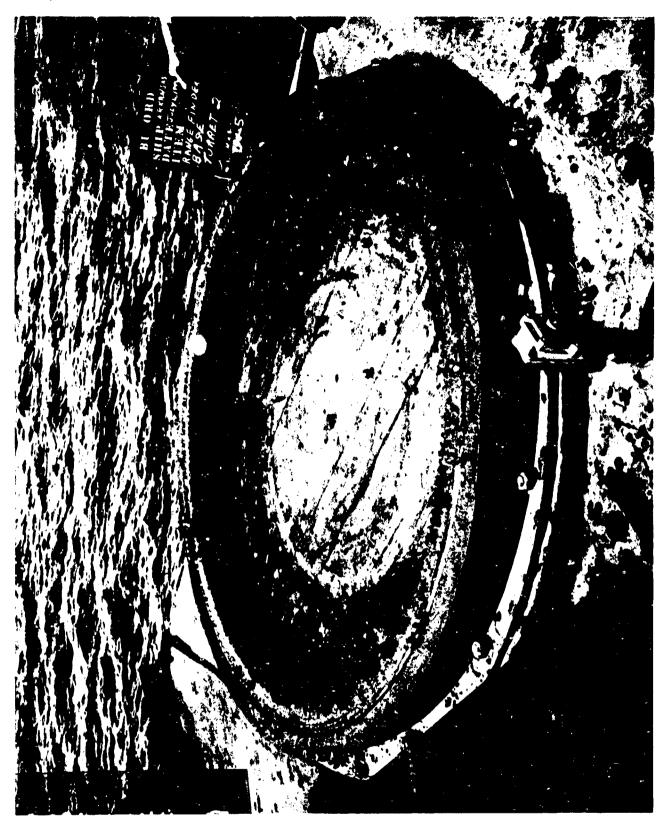
U.S.S. ARKANSAS (BB-33) - After Able Rangefinder, Mk. 10, and Rangefinder Mount. Showing the rangefinder mount after being blown off Turret #2. Photo. No. AA-CR-60-144-4.

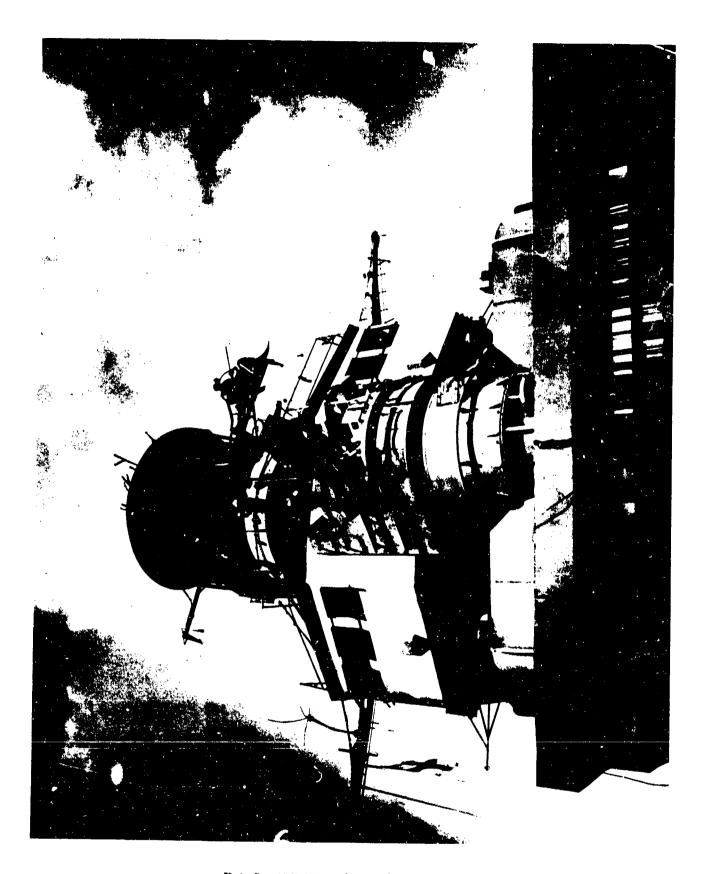
U.S.S. ARKANSAS (BB-33) - After Able Cun Director, Mk. 50, Mod. 4, Serial No. 13 (Fwd. Sky Control) Showing displaced antenna assembly of Fire Control Radar Equipment, Mk. 10. Photo. No. AA-CR-60-144-6.

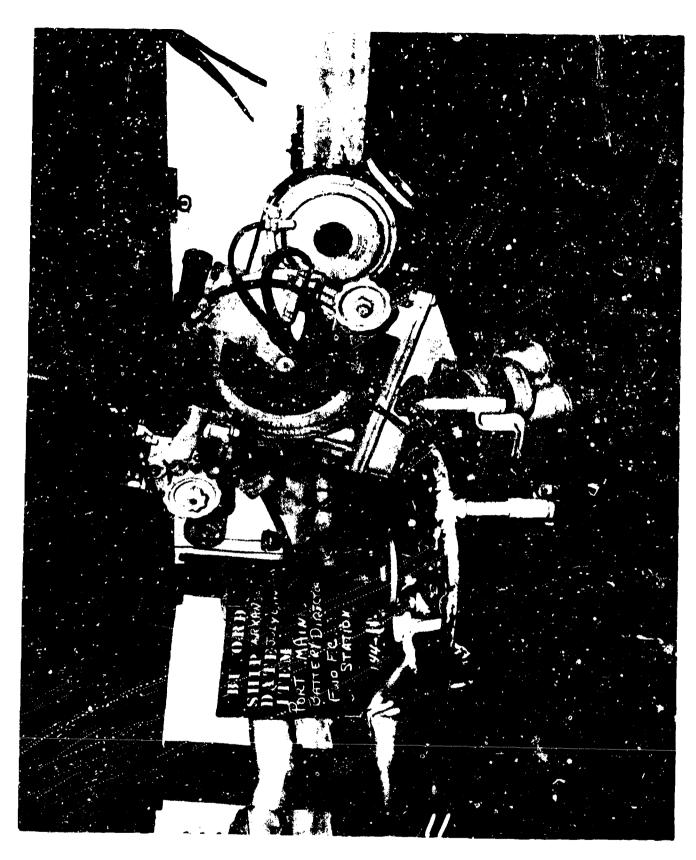
U.S.S. ARKANSAS (BB-33) - After Able Secondary Battery Director, Nk. 7, Mod. 3, Serial No. 2 - Rangekeeper, Nk. 2. Showing shattered cover glass and disengaged knobs. Photon No. AA-CR-60-144-11.

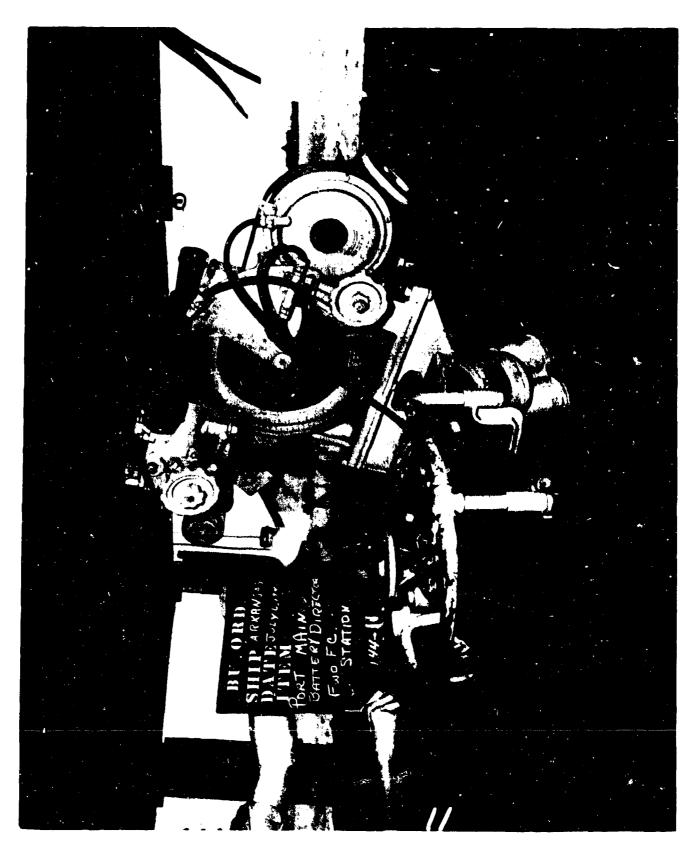
U.S.S. ARKANSAS (BB-33) - After Able Secondary Battery Director, Mk. 7, Mod. 3, Serial No. 2 - Rangekeeper, Mk. 2. Showing shattered cover glass and disempaped knobs. Photo. No. AA-CR-60-144-11.

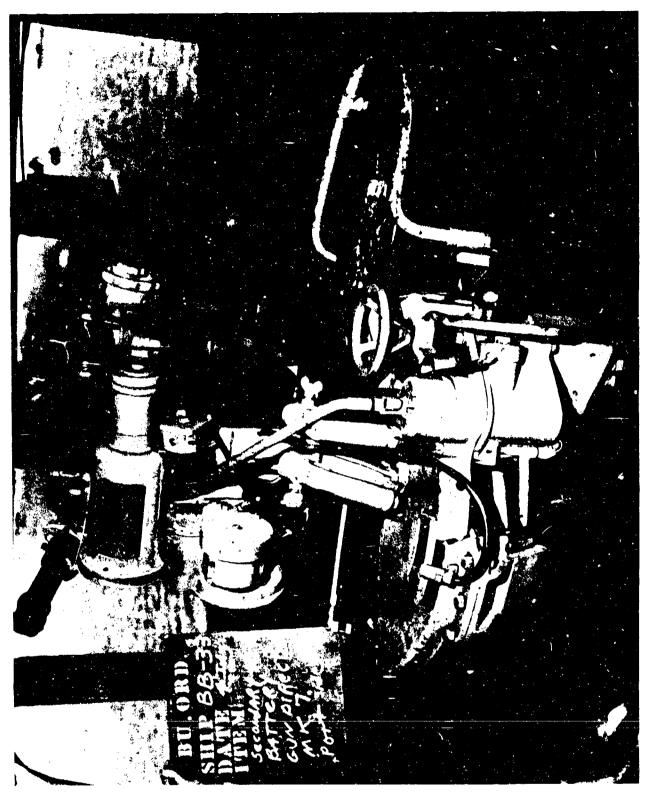
U.S.S. ARKANSAS (BB-33) - After Able
Gun Director, Vickers AA, Mk. 7, Mod. 3,
Serial No. 2, location - Secondary forward, port side.
Showing parted electrical cables, broken turntable
and the shattered glass over the dial group of the
heavily damaged Mk. 2, Mod. 0, Serial No. 216
Ford rangekeeper.
Photo. No. AA-CR-125-2036-7.

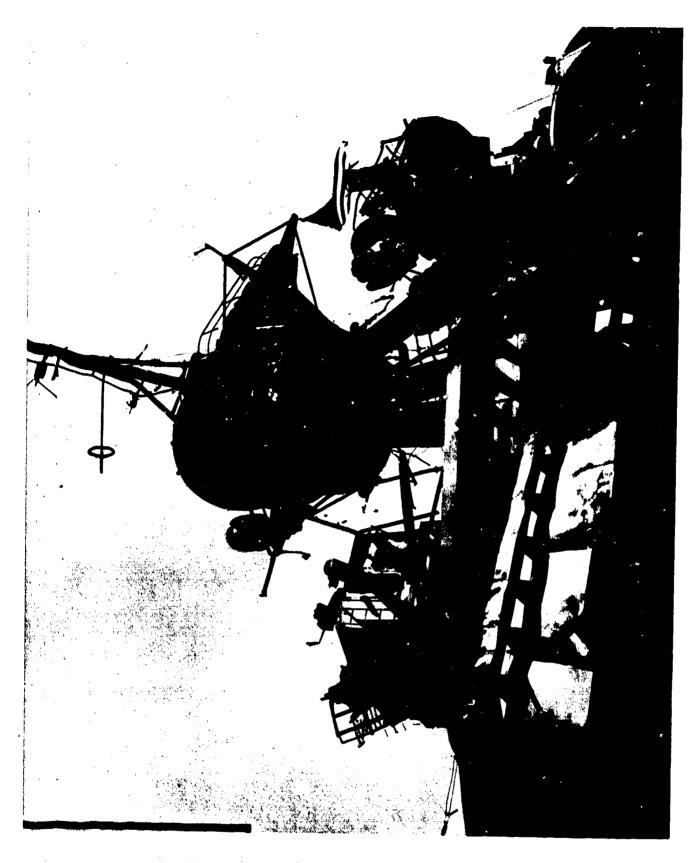
U.S.S. MAN YORK (11-34) - After Able Radar Antenna for Fire Control hader Equipment, Mk. 10, Moc. 5, Serial No. 34, loseted atop the Gun Director, Mk. 50, aft, showing the surface of the plexiglas antenna cover dama, ed by hert. Photo. No. AA-CR-71-2044-3.

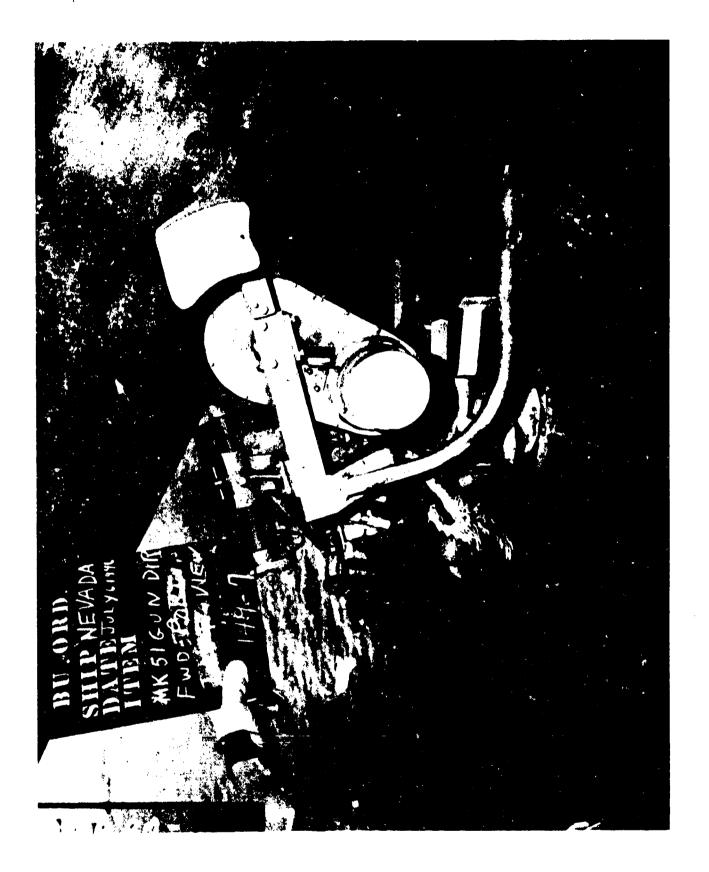
U.S.S. NEVADA (FF-06) - After Able. Gun Director, Fark Sl. Fod. 2. Gun Sight, Mark 14, Hod. 8, (Forward port) showing the broken locking-in and the tracking held formed by the atmospheric exhaust life.

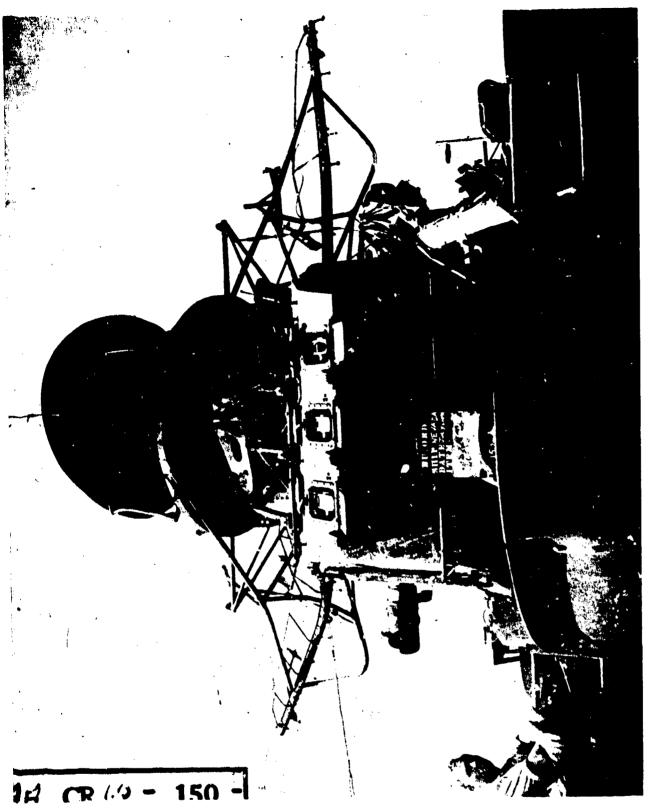
U.S.S. MEVADA (BE-36) - After Able
Gun Director, Mark 37, Mod. 37, and Fire
Control Redar Equipments, Marks 12 and 22,
located in Sky 4 (Aft). Showing the torn legging
on the rangefinder end-box on the director, and
the twisted and torn entenne crosslevel support
beam and broken pieces of entenne structure of
the radar equipments.
Photo. No. AACR 60-150-5.

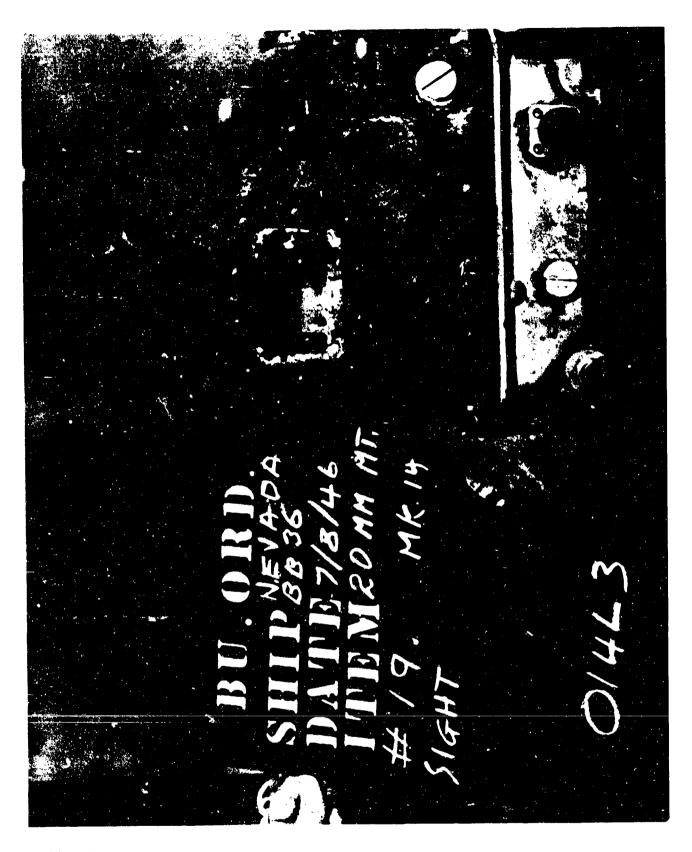
U.S.S. MEVADA (BB-36) - After Able Cunsight, Mk. 14, Mod. 6 (20 MM Cun #19) Showing broken rear window, discolored interior mechanism, and socrahed paint. Photo. No. AA-CR-97-1535-6.

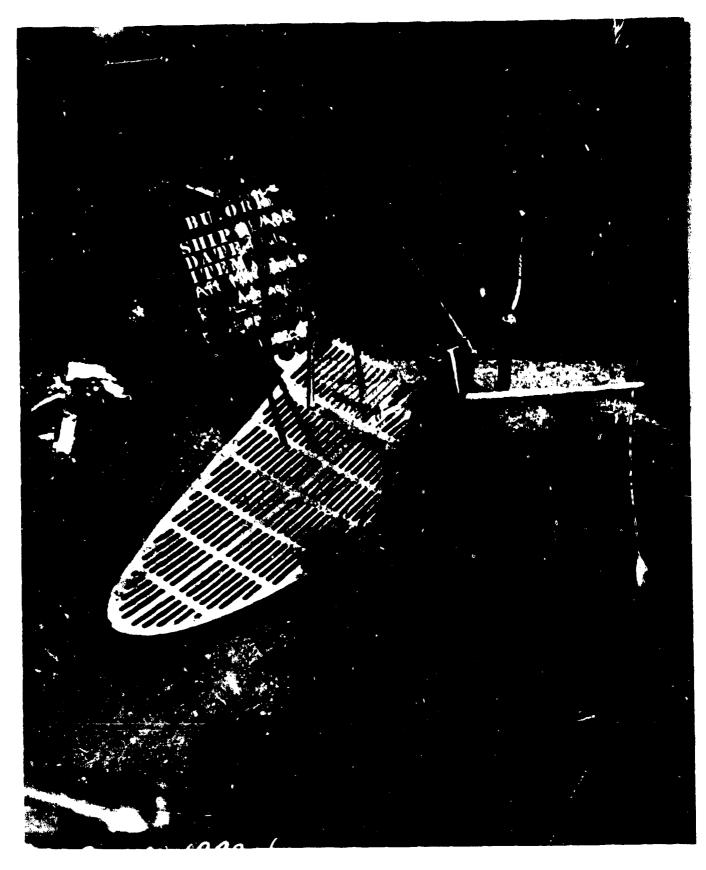
U.2.S. NEVADA (EB-36) - After Atle Roder Antenne, Mark 22, Aft, showing broken reflector. Photo.No. AACR 234-1992-6.

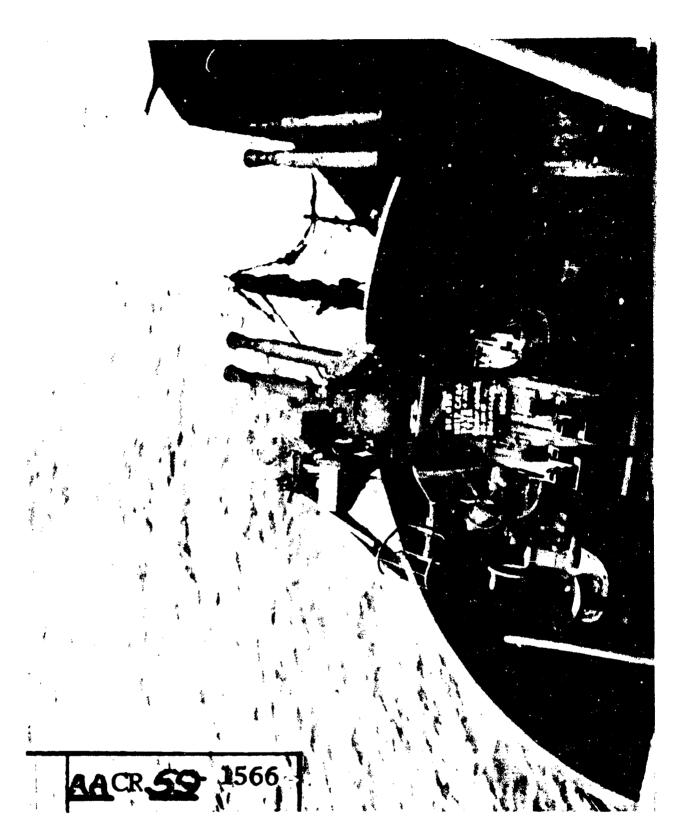
U.S.S. FFHSACODA - CA24- After Able Mk. 28, Mod. 2 Fadar Antenna and Mount, Mark 19 (Starboard Gun Fire Control System Mark 63). Showing folded and torn antenna reflector, bent antenna coaxial feed line and broken antenna reflector support spider. Photo. No. AACh 69-1566-5.

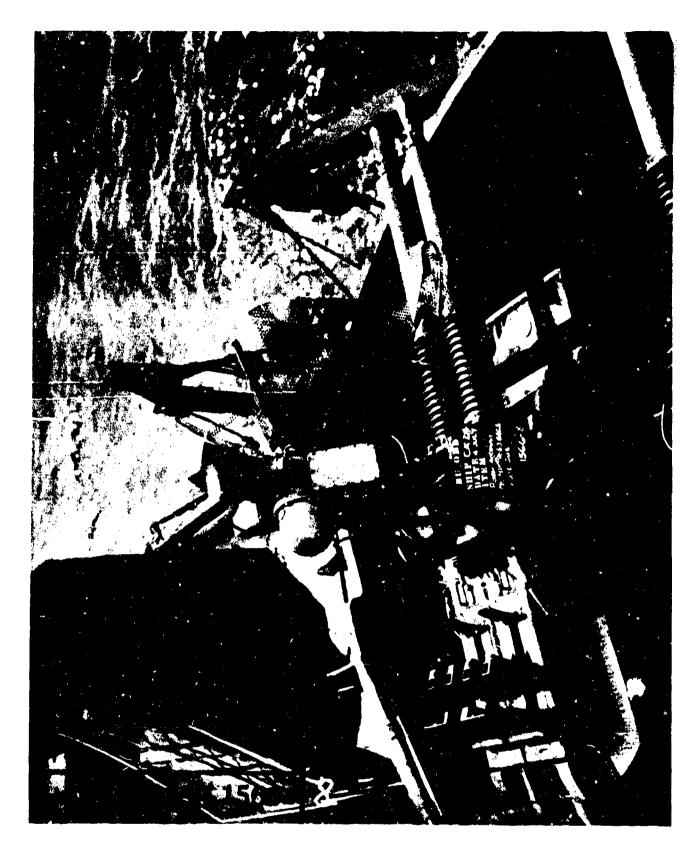
U.S.S. PENSAGOLA - CA24- After Able, Mk. 26, Mod. 2, Radar Antenna and Mount, Mark 19 (Starboard Gun Fire Control System, Mark 63). Showing fragments of reflector surface, damaged coaxial entenna feed line, and broken reflector support spider. Photo. No. AACR 59-1566-6.

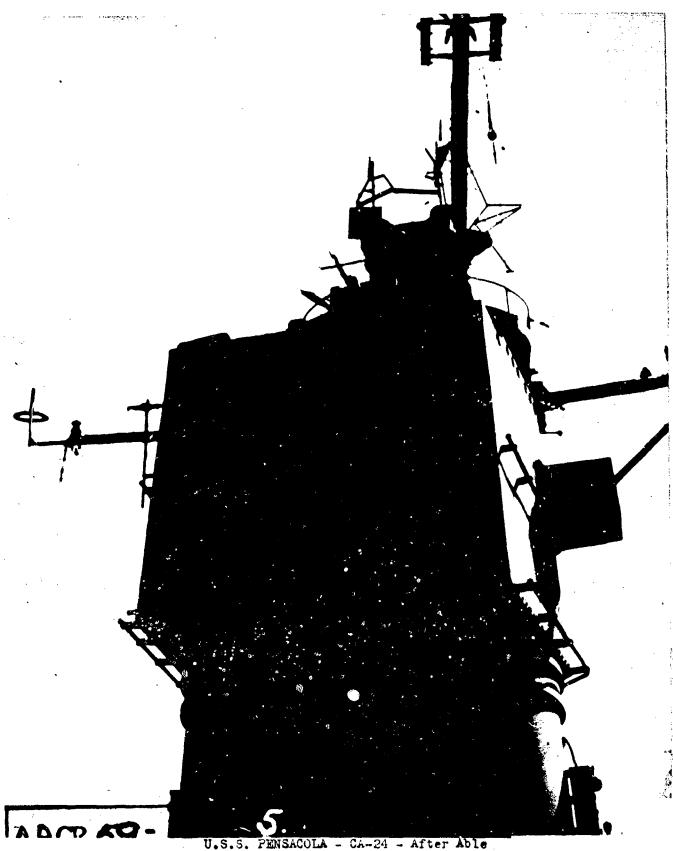
U.S.S. IENSACOLA - CA24 - After Able Hadar Antenna Assembly for hadar, Mark 28, Mod. 3, Serial 575. (AA Gun Director, Mark 33, forward). Showing folded reflector, bent antenna coaxial feed, and damaged reflector support spider. Photo. No. AACK 59-1567-4

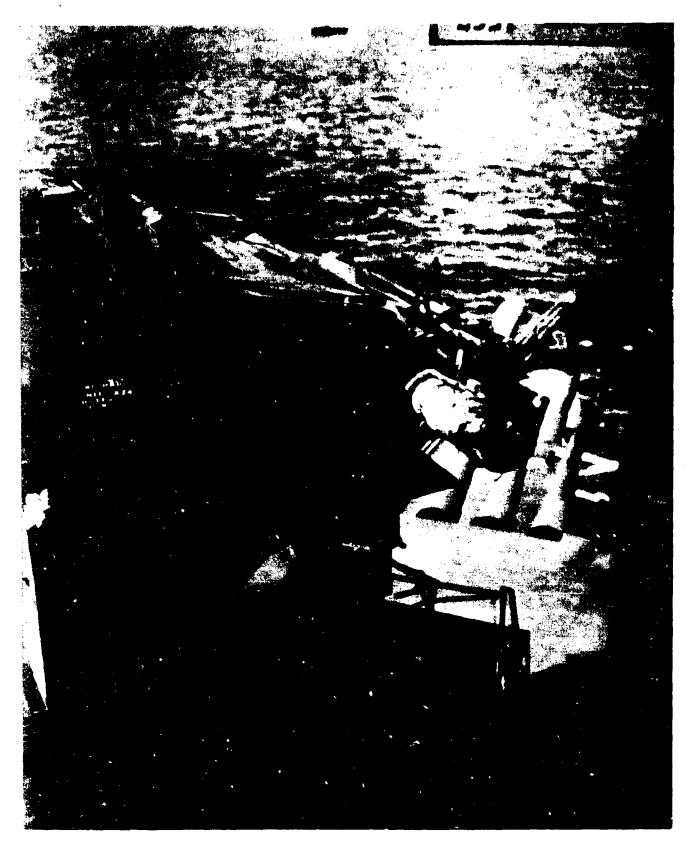
U.S.S. FENSACOLA - CA24 - After Able

and torn shield and burned paint on rangefinder.

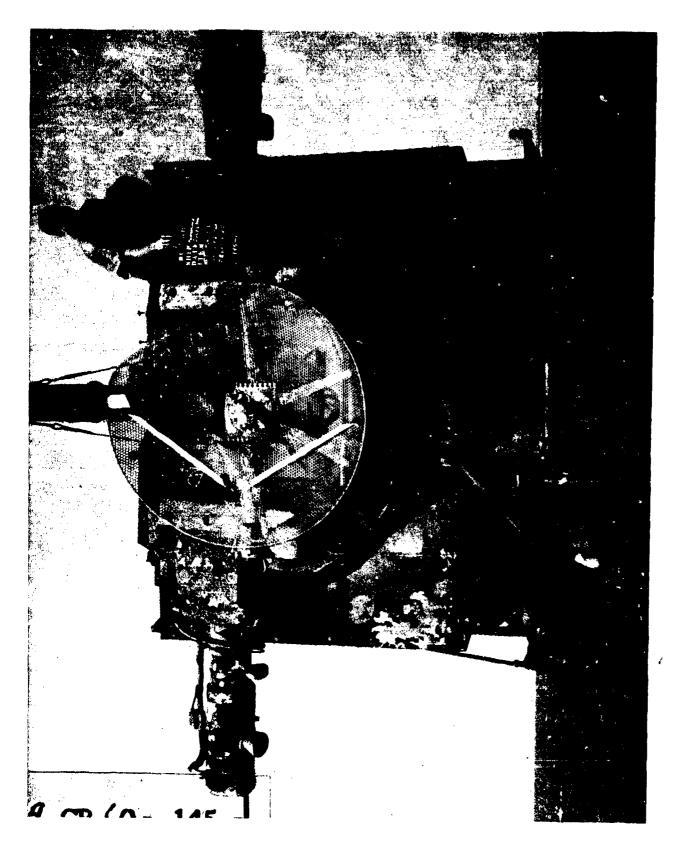
U.S.S. PENSACOLA (CA-24) - After Able Gun Director, Mk. 33, Mod. 16, and Antenna of Fire Control Radar Equipment, Mk. 28, Mod. 3 (After superstructure) Showing scorched paint on the director shield and damaged radar antenna reflector. Photo. No. AA-CR-60-145-1.

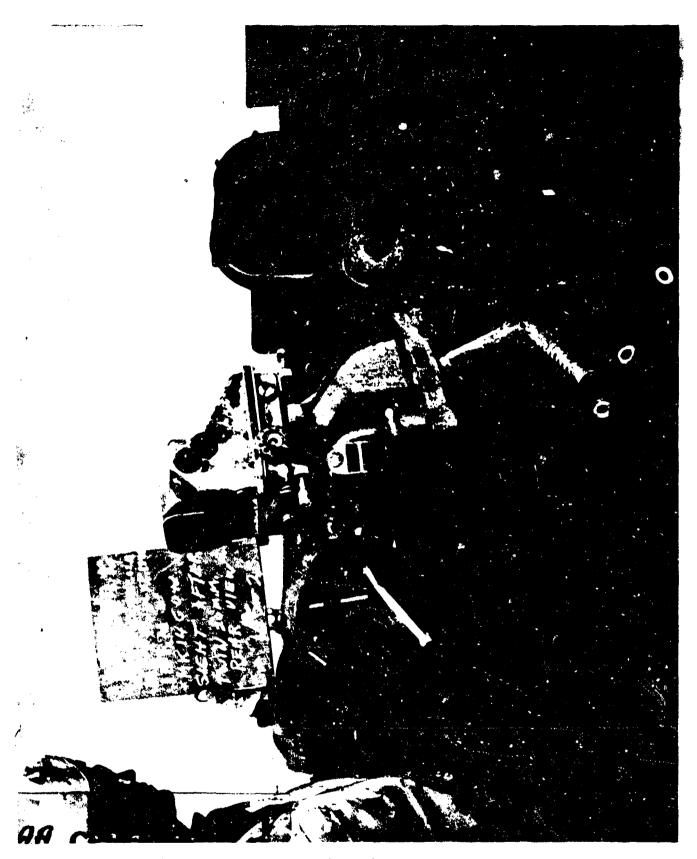
U.S.S. PENSACOLA (CA-24) - After Able Ommaight, Mk. 14, Mod. 6, Serial No. 92103 (No. 21-20 MM gun). Showing scorched paint and the broken rear window. Photo. No. AA-CR-60-145-2.

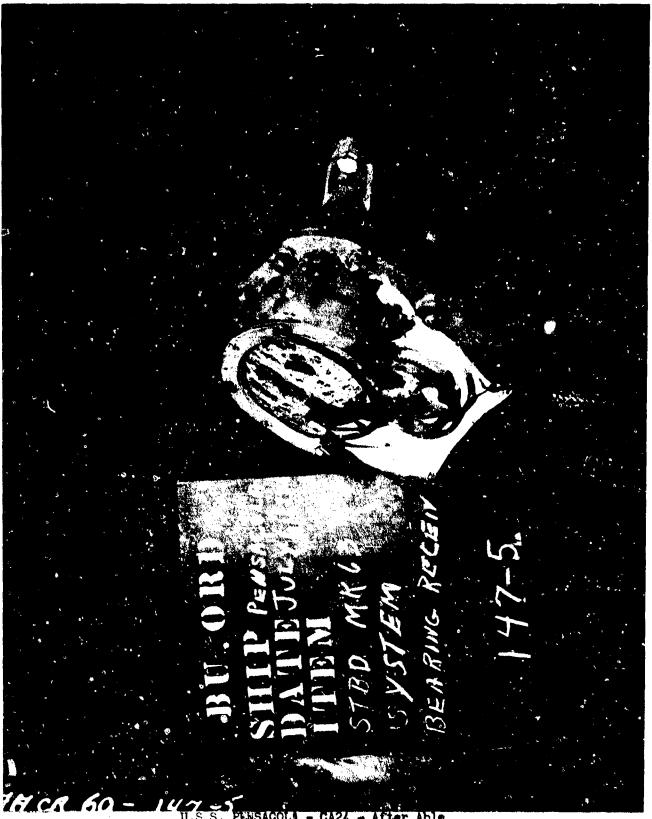
U.S.S. PENSAGOLA - CA24 - After Able Bearing Indicator, Mark 10, Mod. 0, Serial No. 3435 (Stbd Mark 63 GFCS After Signal Flatform). Shows the Broken Window and case of the bearing indicator. Photo. No. AACR 60-347-5

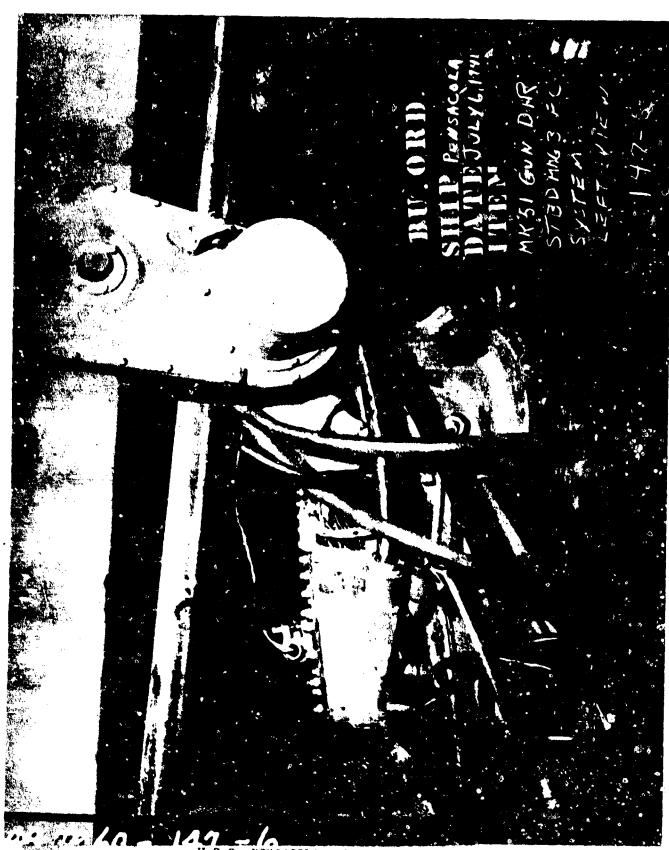
U.S.S. PENSACOLA - CA24 - After Able Gun Director, Mark 51, Mod. 3, Serial Mo. 12645. View of heavily damaged director. Photo. No. AACR 60-147-6

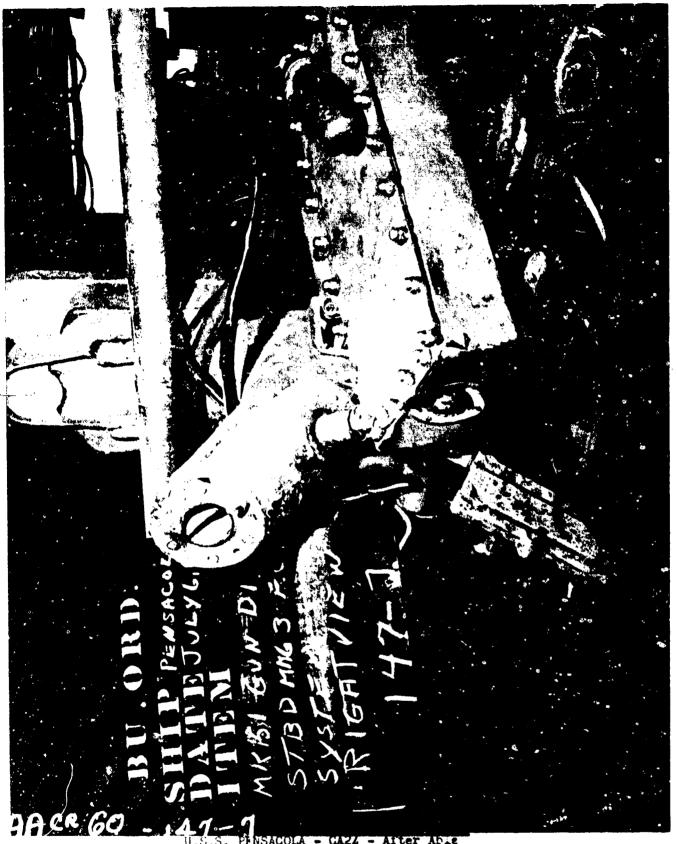
U.S.S. PHNSACOLA - CAZ4 - After Able Gun Director, Mark 51, Mod. 3, Serial No. 12645. View of heavily damaged Merk 51 director. Photo. No. AACH 60-147-7

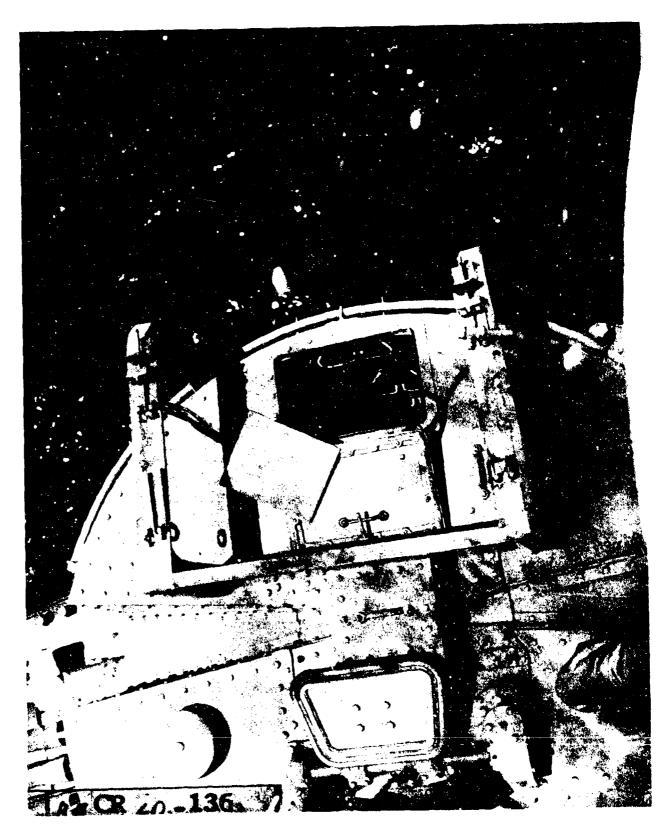
U.S.S. SALT LAKE CITY (CA-25) - After Able Antenna, Fire Control Radar Equipment, Mk. 3, Mod. 0, Serial No. 14 (Forward Main Battery Director) Showing remaining fragments of cast light-metal alloy antenna base supporting members. Photo. No. AA-CR-60-136-10.

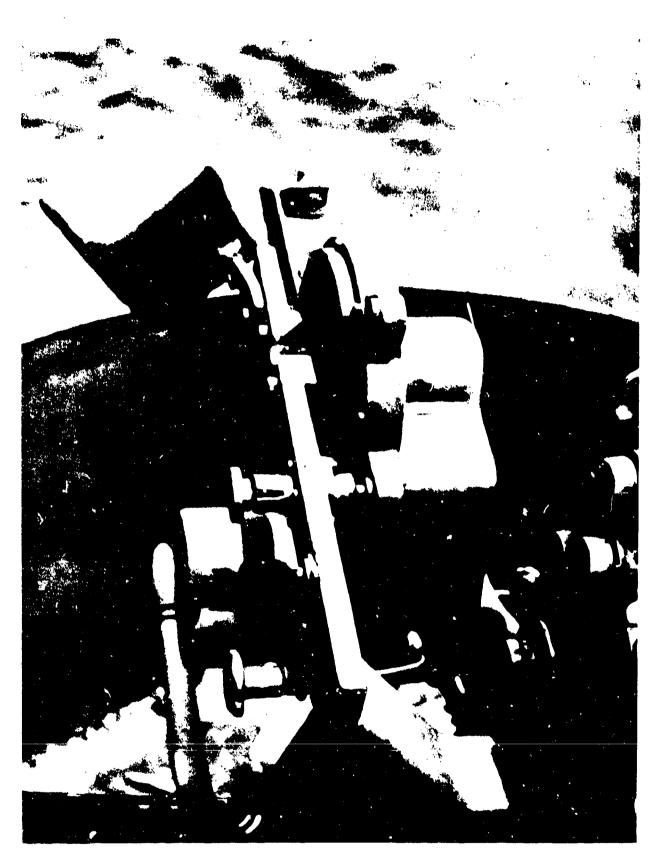
U.S.S. SALT LAKE CITY (CA-25) - After Able Cross Level Resistor Unit (Stable Element, Mk. 2, Mod. 10, in Gun Director, Mk. 33, Aft) Showing two broken connections to resistors. Photo. No. AA-CR-87-2542-6.

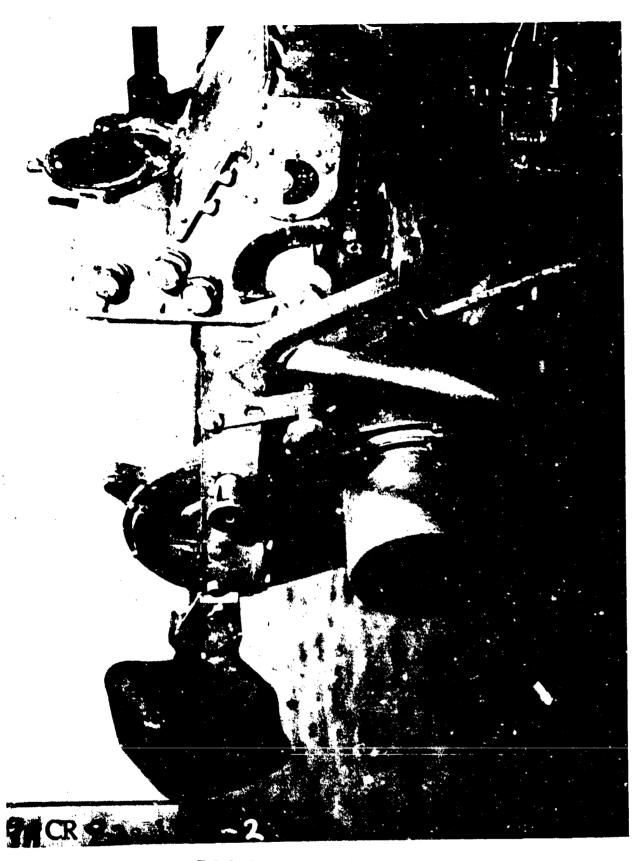
U.S.S. INDEPENDENCE (CVI-22) - After Able Gun Director, Mk. 51, Mod. 2. Showing the bent counterbalance weight hanger and the broken range setting extension handle.
Photo. No. AA-CR-92-1780-11.

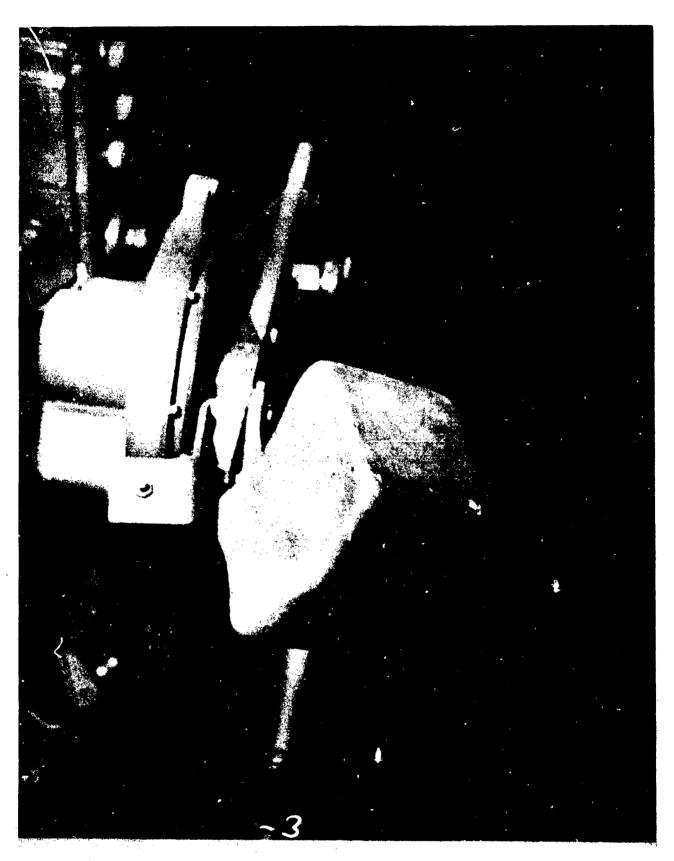
U.S.S. INDEPENDENCE (OVI-DE) - After Alle Gun Director, Nark 51. Showing close-up of bent right counterbelance weight hanger. Fhoto. No. AACR 92-1781-2.

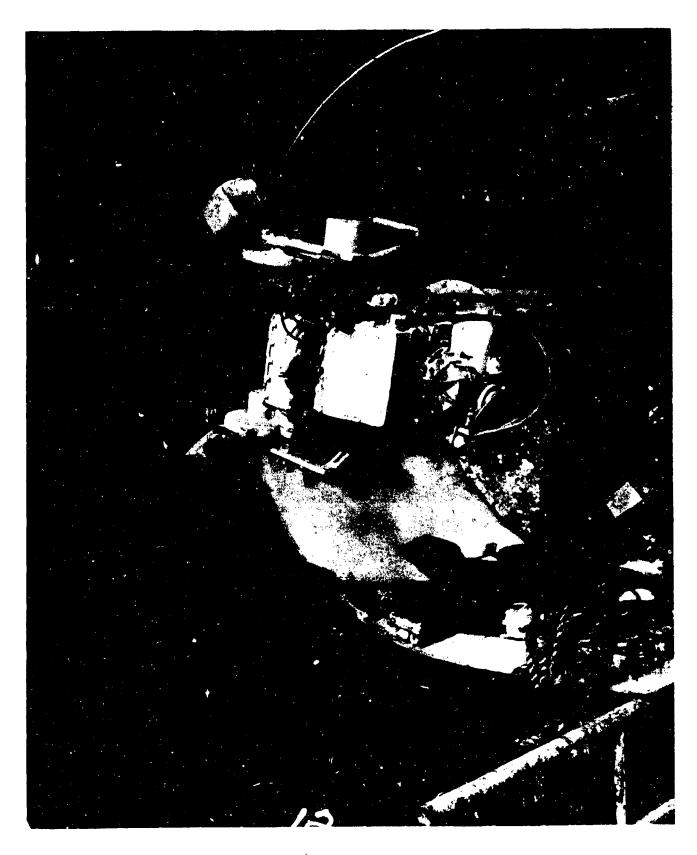
U.S.S. INDEPENDENCE (CVL-22) - After Able Gun Director, Mark 51, and Gunsight, Derb 14. Showing scorched paint, shattered filter glass and bent supports of couterbalance weights. Photo. No. AACR 92-1781-12.

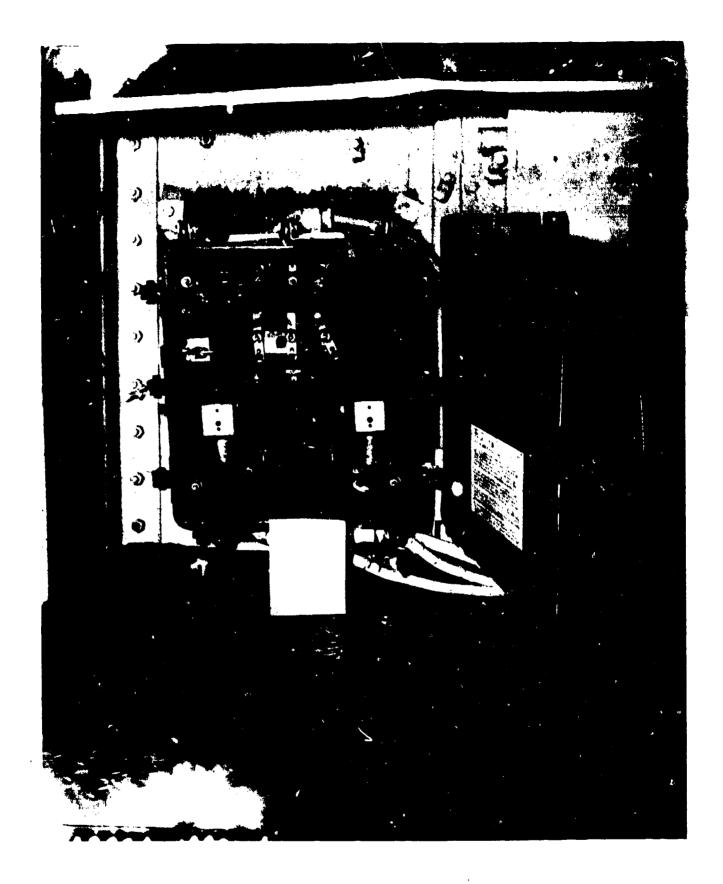
U.D.C. HALFH TALBOT (DD-390) - After Able Stable Element, Mk. 2, Mod. 1, and Gun Director, Mk. 33, shield (Gun Director, Mk. 33). Showing the cross level telescope mounting bracket separated from the stable element case, and the cracks in the circular shield. Thoso. No. AA-CY-234-1984-12

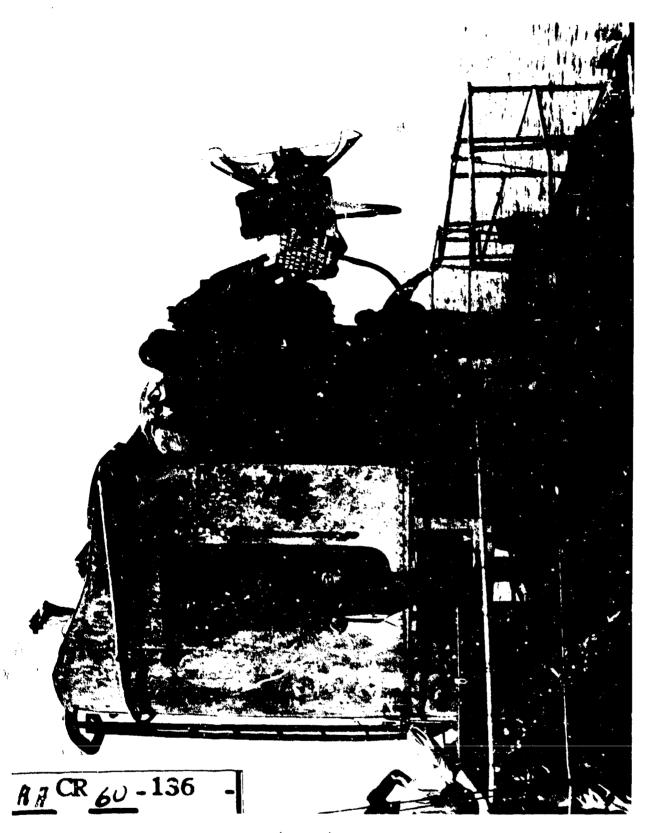
U.S.S. THIND (DD-404) - After Able
Antenna Radar, Mk. 28, and Gun Director, Mk. 33,
Mod. 9 (Forward superstructure).
Showing twisted reflector and damaged feed of the
radar antenna and the sprung door, burned paint,
and cracked shield of the director.
Photo. No. AA-CR-60-136-1.

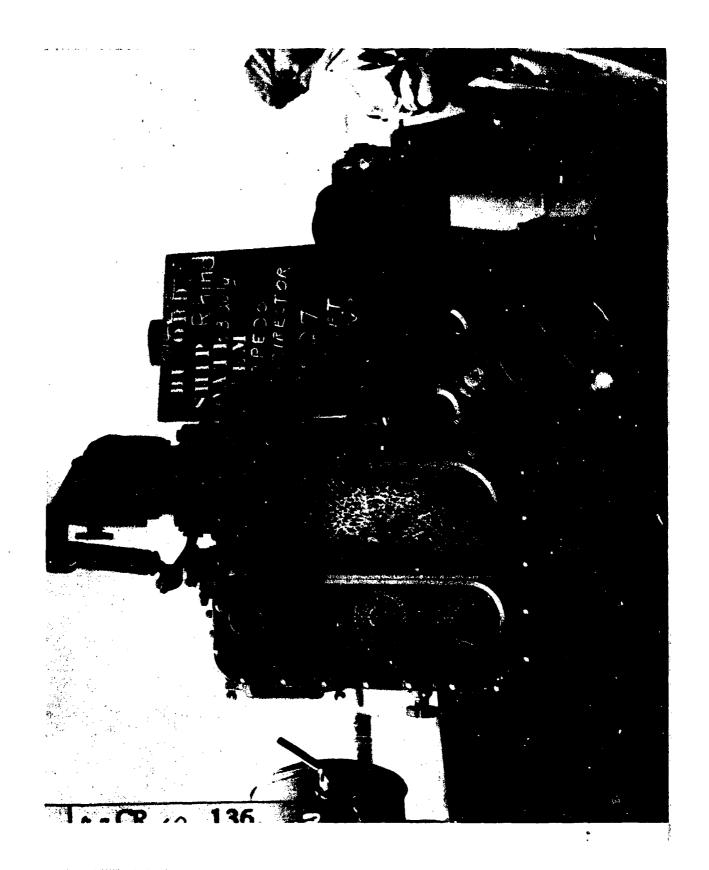
U.S.S. REIND (DD-404) - After Able
Torpedo Director, Mk. 27 - Mod. 1, Serial #1986 (Port
Showing the shattered glass winds a covering the
Sown ship and target dial group.
